REMEDIAL SITE ASSESSMENT DECISION - EPA REGION II

Site Name: SGS Thomson Micro Electronics EPA ID#: NJD044655140 State ID#:

FINAL DRAFT
ENVIRONMENTAL PRIORITIES INITIATIVE/
PRELIMINARY ASSESSMENT (EPI-PA)
SGS THOMSON MICRO ELECTRONICS
CITY OF SOMERSET
SOMERSET COUNTY, NEW JERSEY
CERCLIS NO.: NJD044655140

SEPTEMBER 1992

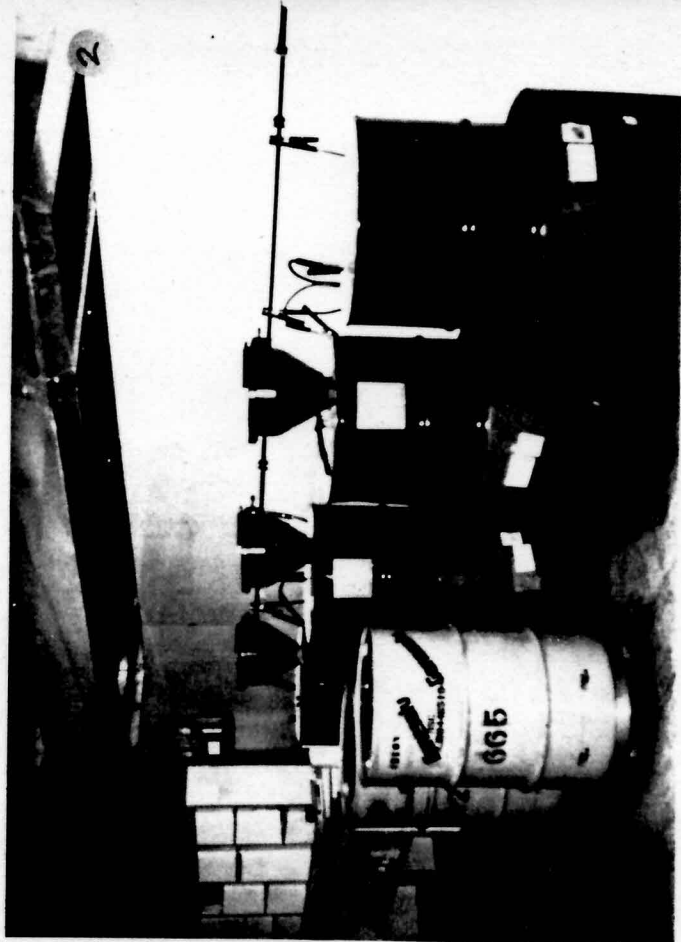
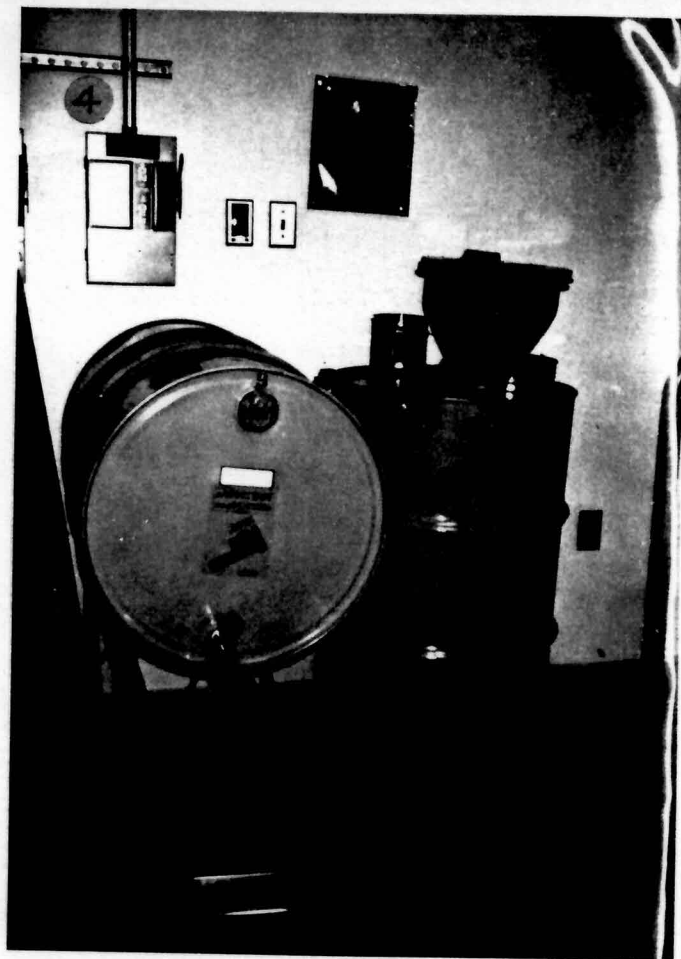
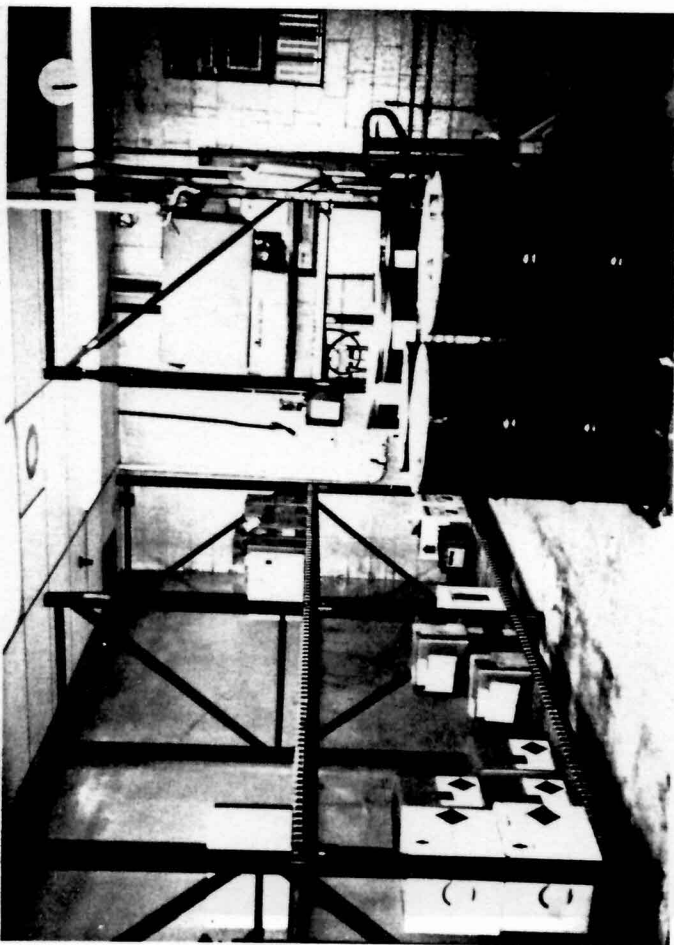
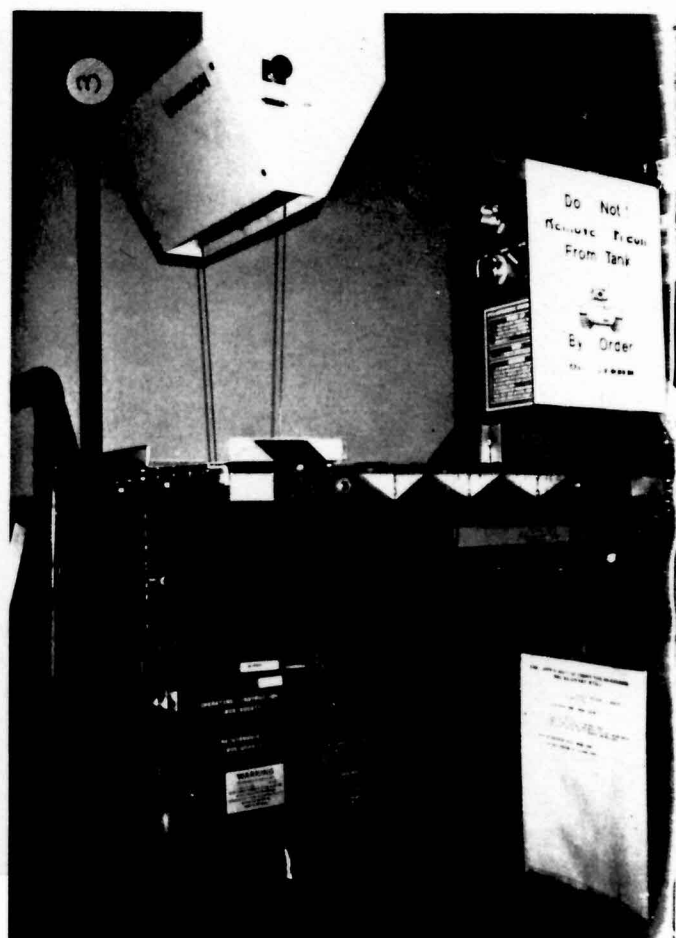
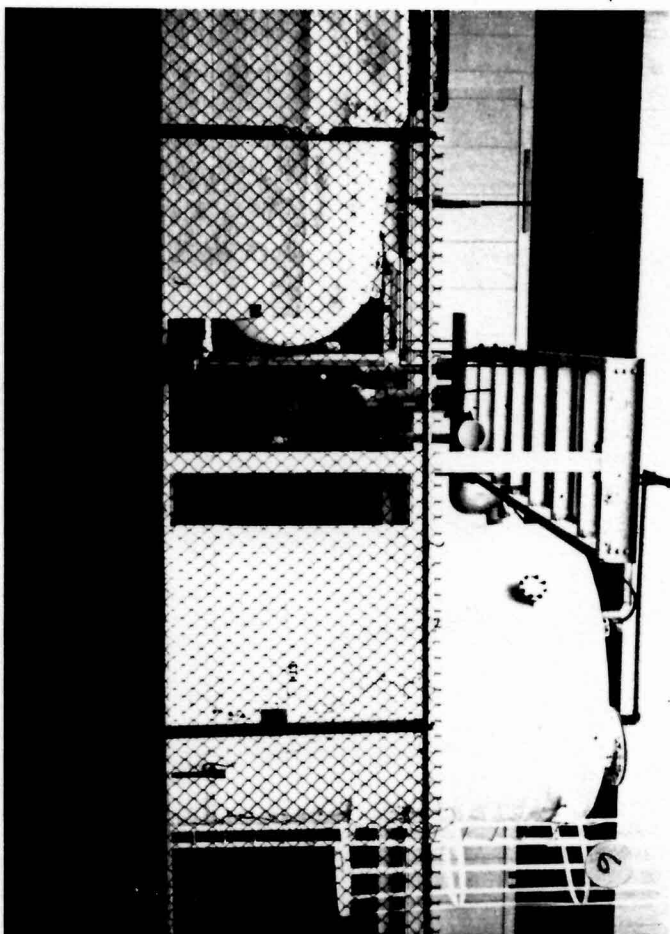
FIGURE 2

- 1) PHOTO #1 - Drums in the Storage Area (Former Plating Shop) in the North Building.
Taken: August 4, 1992 Facing: North
- 2) PHOTO #2 - Wastestream Drums in the Storage Area (Former Plating Shop) in the North Building.
Taken: August 4, 1992 Facing: North
- 3) PHOTO #3 - Vapor Degreasing Unit in North Building.
Taken: August 4, 1992 Facing: East
- 4) PHOTO #4 - Drums of freon used in Degreasing Unit. Freon replaced every 2-3 months.
Taken: August 4, 1992 Facing: North
- 5) PHOTO #5 - Monitoring wells on north end of site near the Former Drum Storage Area.
Taken: August 4, 1992 Facing: North
- 6) PHOTO #6 - The Equalization Tank of the Neutralization System on south property.
Taken: August 4, 1992 Facing: West
- 7) PHOTO #7 - Neutralization System on south property.
Taken: August 4, 1992 Facing: West
